ASSESSING THE EFFECT OF DAMPNESS IN THE LOWER PARTS OF

BUILDING IN THE DZOWULU LOCALITY

AUGUST, 2017

EDINAM AKPALU-BOATENG

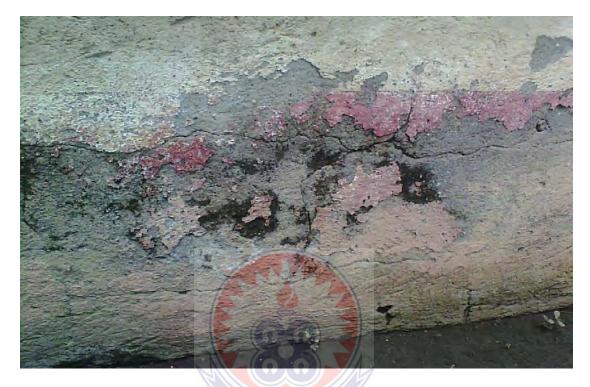
As shown in figure 4.1, peeling off of paints on building were visible where paints where paints flake off from the walls as a result of the lack of adhesion between the paint surface. The constant presence of moisture in the wall caused the paints to loss adhesion thereby peeling off of a shown in Fig. 4.1 and Fig. 4.2. It was noted that eighteen (18) building

samples representing seventy-two percent (72%) had their paints surfaces peeled off. This situation was noted as the major defect observed on the walls of most buildings during the visual survey.

Fig. 4.1 Peeling off of paints, cracks, stains and patches of mold

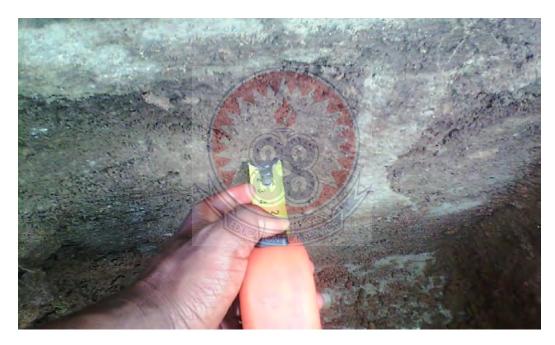
The observation of rendered an unrendered walls revealed that chalking or wearing of plaster and blocks were visible. In Fig. 4.2, the moisture in the plaster and block has led to the disintegration of the sand particles into powder. The study however showed that chalking occurred as a result of either wrong mortar mix on chemical reactions or both due to the presence of moisture. From table 4.1, it was observed that twelve (12) our of twenty-five (25) building samples surveyed were identified as having this defect representing forty-eight percent (48%).

Fig. 4.2 Chalking of block

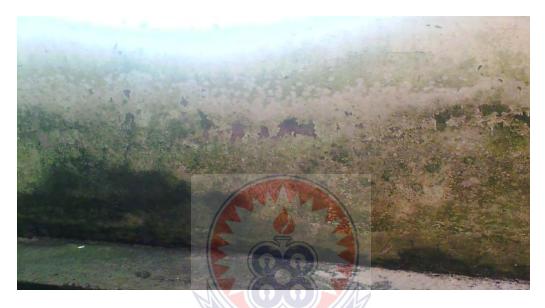
From the survey, patches of mold were found on walls as shown in Fig 4.1 and 4.3 Moisture in building materials promoted the growth of microbes on walls. The microbe growth depends on the moisture, temperature conditions, time and nutritive status of the materials. From all of these conditions moisture was seen as the key factor for the growth of microbes.

The presence of some microbes such as mold of fungi has some health effects. Buildings that has been affected by moisture lead to massive growth of mold within a very short period of time. From table 4.1, building samples affected with Stains and patches of mold on them are twenty (20) which represent eighty percent (80%) of the selected sample.

Fig. 4.3 Peeling off of Paints, Stains and patches of mold

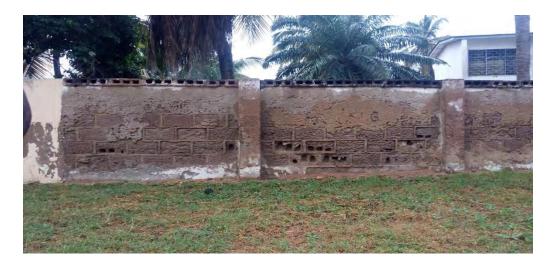
It was observed that moisture has caused the disjointing or breakup of building components, between block wall and floor concrete, block wall or concrete and wooden frame, as shown in Fig. 4.4. The constant presence of moisture in the building structure has rendered the fabrics of the component loose adhesion and also promoted wood rot. Out of twenty-five (25) building samples, disintegration of building components was present on nine (9) building samples which represent thirty-six percent (36%).

Fig. 4.4 Disintegration of building components and Wearing of plaster
