UNIVERSITY OF EDUCATION, WINNEBA

**ASSESSING THE IMPACTS OF QUARRYING ON THE GEOLOGICAL
STRUCTURE OF WEIJA HILLS IN GA SOUTH MUNICIPALITY**

**A thesis in the Department of Geography Education,
Faculty of Social Sciences, submitted to the School of
Graduate Studies in partial fulfilment
of the requirements for the award of the degree of
Master of Philosophy
(Geography Education)
in the University of Education, Winneba**

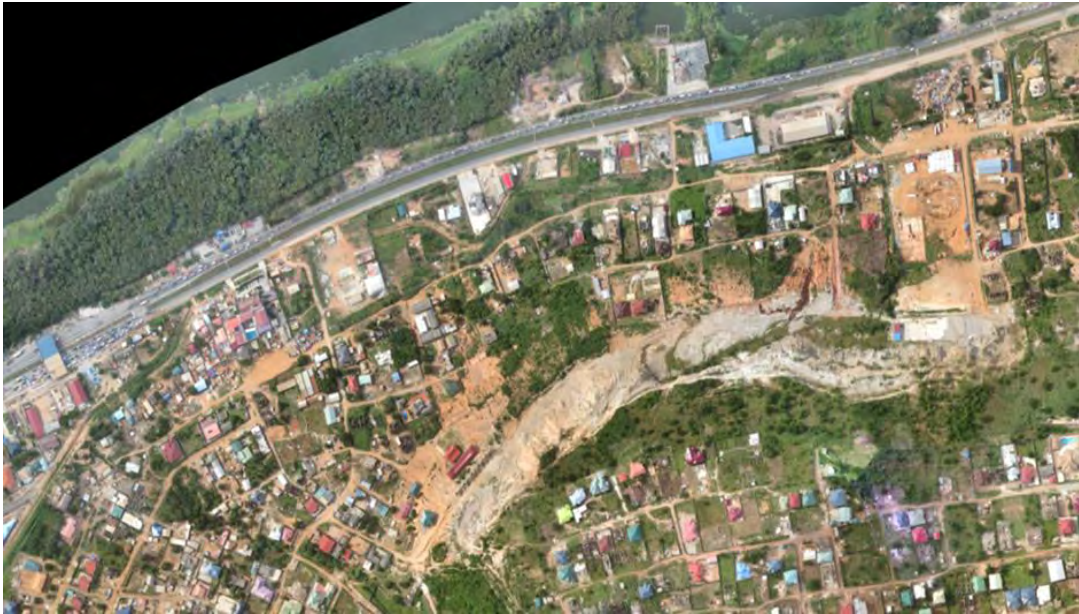
Figure 4: Quarried sites A on the Weija Hills.

Both primary and secondary sources of data were adopted for the study. The primary data were collected directly from field observation during which much data were gathered including photographs. Several visits were made to quarry sites at different seasons with the idea of getting different information brought by each season. This provided the opportunity to observe, understand, assess and explore the nature and extent of the impact of quarrying activities to avoid being speculative. Based on the preliminary observation, three quarry sites referred to in the study as A, B & C were selected for the study. Site A in this study was located opposite to the Densu River along the Mallam-Kasoa highway to Broadcasting junction. Site B was located at the side of the hill that faces the Tuba road, near NetLynk Estate while Site C was located at Bortianor extent of the Weija Hills. After assessing the information gathered from the various sites, the researcher concluded that site A was the most affected by quarrying activities among the three sites chosen for the study. To that effect, Site A became the area of interest in assessing the impact on the geological structure and it was also modelled for the slope stability analysis. The figure below shows an aerial photograph of quarried Sites A taken by drone not to scale.

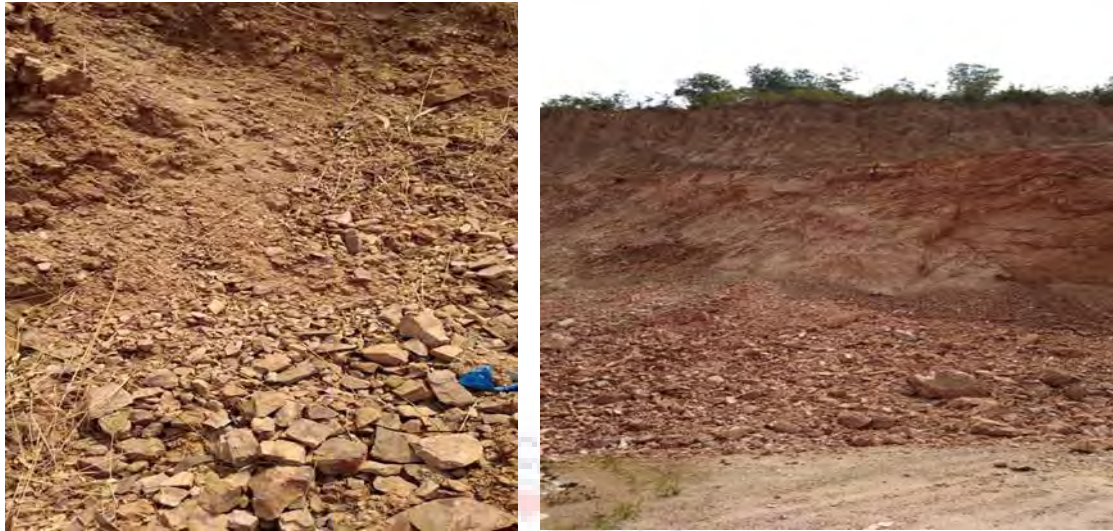
Figure 6: Showing quarrying materials at Site B

The sandstone was fine grained and had a red ferruginous cement. It is generally very friable and easy to quarry and to carve. They had been metamorphosed into phyllite, and quartz-schist which were deeply weathered and altered by erosion.

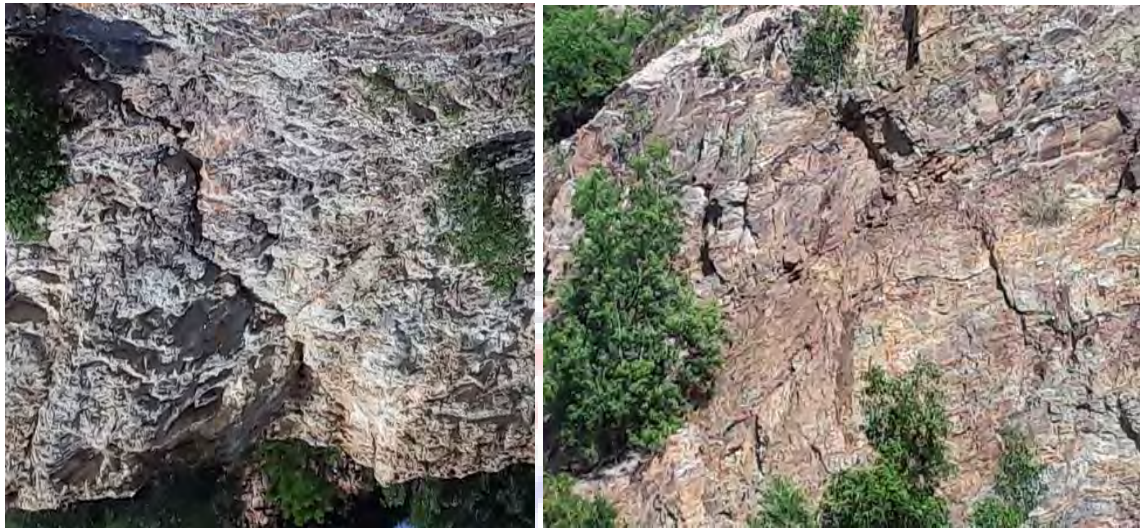
Figure 7: Showing cracks in rocks after being exposed by quarrying at Site A

The study found out that, some rock masses of abandoned quarried sites had developed cracks in them as shown by *figure 7* since the rocks had been exposed and worked on by climatic elements. The cracks on the quarry floor had been widened and deepened by erosion as shown by *figure 8*.

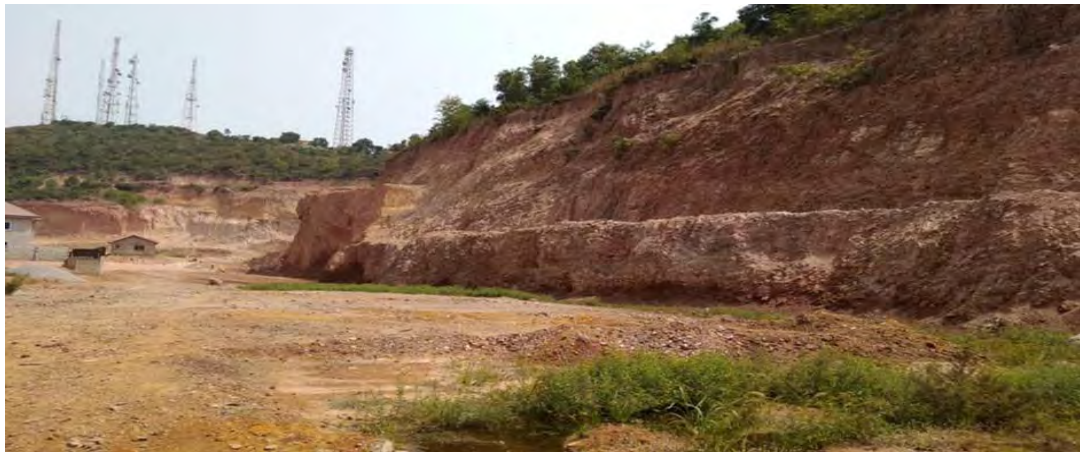
Figure 9: Showing portions of the hills that has been become steep due to quarrying and lowered portions prepared for development at Site B

The study found out that, quarrying activities had made various portions of the hills flat leading to expansion in building development and settlement. Also, as the side of the hill was cut off, the original slope had been altered into steep slopes as *shown in figure 9 below*. The topsoil and underlying bedrock had been removed.

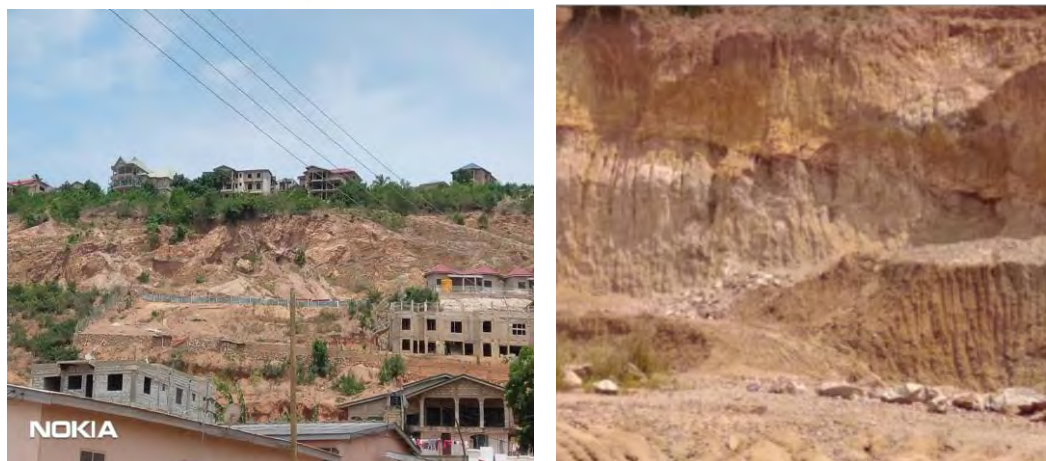
Figure 10: Showing the destruction of the aesthetic beauty of the Weija Hills at Sites B&A respectfully

Also, the landscape had been destroyed at the excavated portions of the hills. The aesthetic beauty of the hills had also been lost as shown in *figure 10 below*.

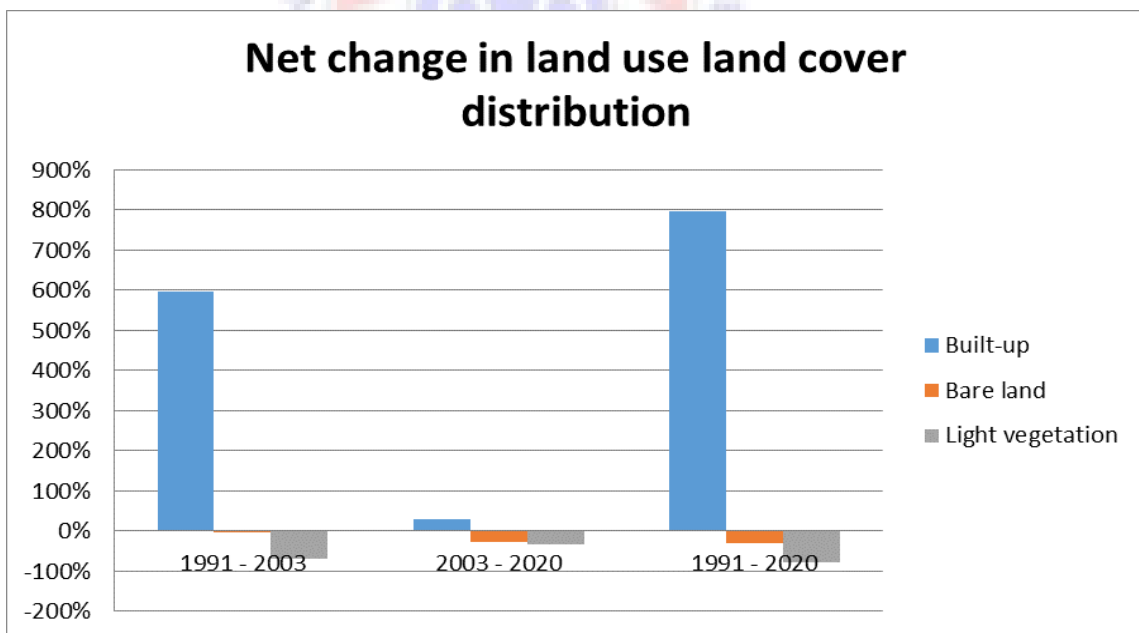
Figure 14: Net change in land use land cover distribution

2020, the land use land cover feature type of built-up areas continued to be the domineering feature type further increasing by 28.38% within the 17-year period of 2003 to 2020. Built-up areas covered a land area of 10.5174 square kilometres (65.1%) in 2020. In all, within the 29-year period (1991 to 2020), built-up areas increased significantly by 796.09%. Bare land areas further decreased within the 17-year period by 25.87% covering an area of 3.5946 square kilometres (22.3%) in the year 2020. Light vegetation, also further decreased by 34.39% while it covered a land area of 2.0412 square kilometres (12.6%) in the year 2020. Thus, bare land and light vegetation suffered major losses to their coverage between the years 1991 to 2020, a 29-year period. Bare land areas and light vegetation decreased significantly by 29.39% and 79.41% respectively. The figure below illustrates the net change in the various land use land cover feature types between the years 1991 to 2020.

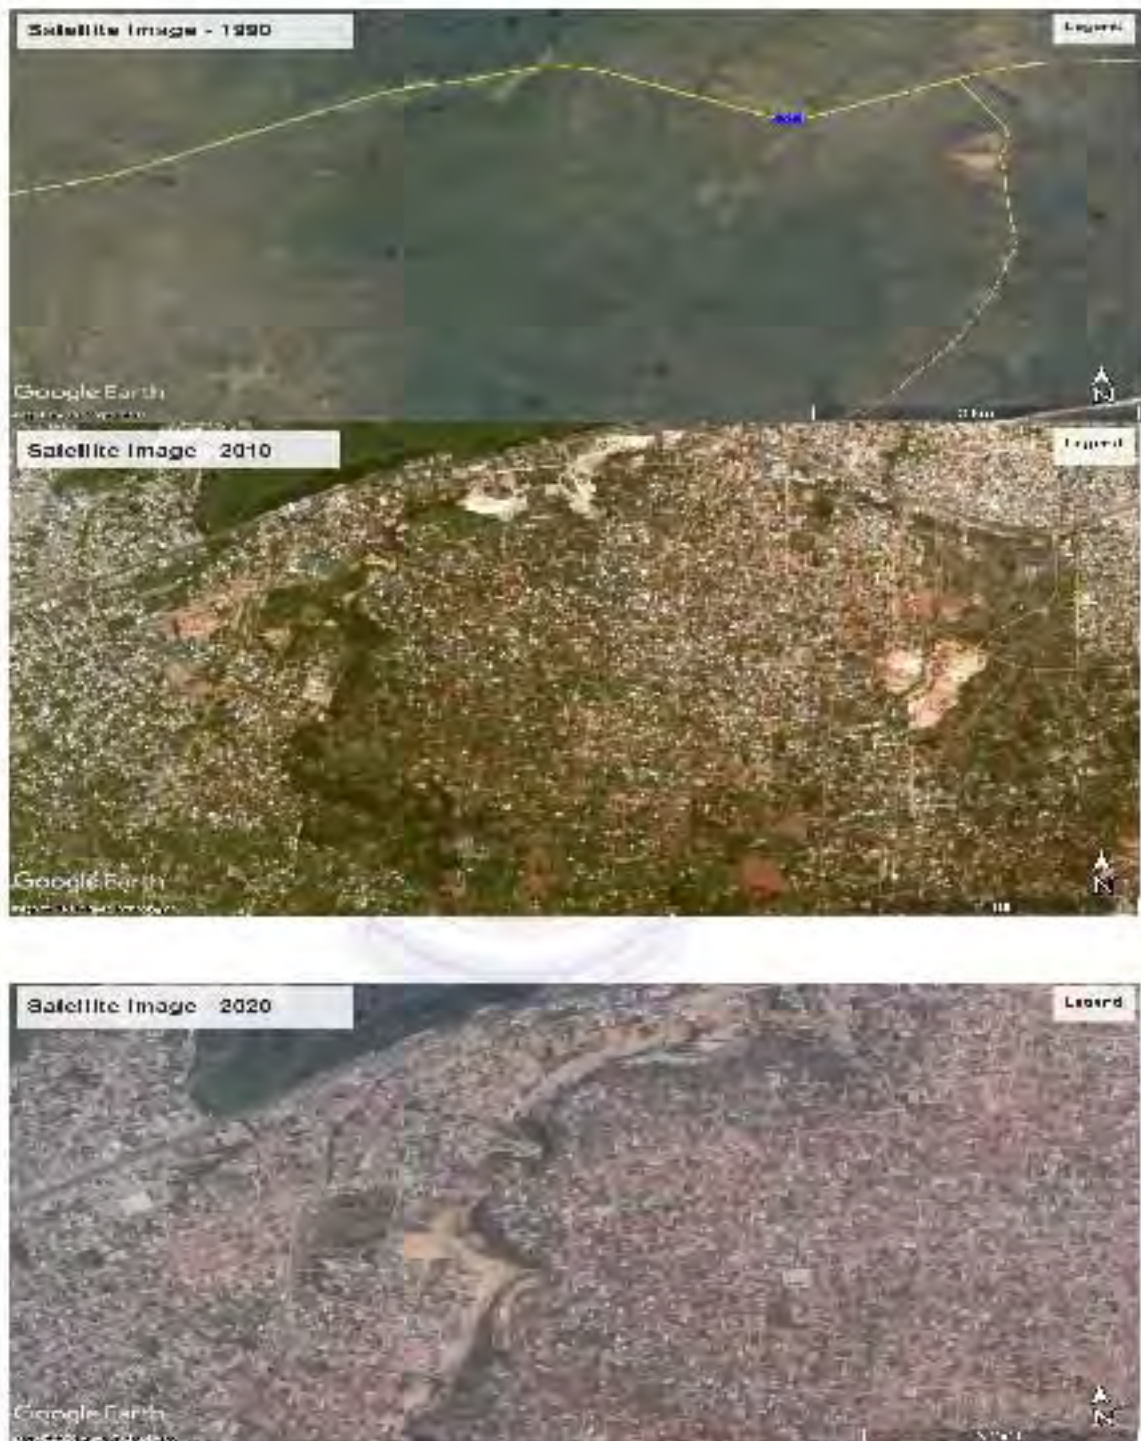
Figure 16: Land Use Land Cover Maps of Weija Hills for 1990, 2010 and 2020

Satellite images taken from Google Earth for the years; 1990, 2010 and 2020 also showed a drastic change in land use land cover over a period of thirty years as shown below in *figure 16*. In 1990, the Weija Hills was covered with vegetation and had few bare areas. By the year 2010, the hills had lost its vegetation cover to development, that is, built-up. By 2020, the few green areas had also been developed. The study

found out that, this development had been made possible because, the hill was quarried and made plain for settlement.

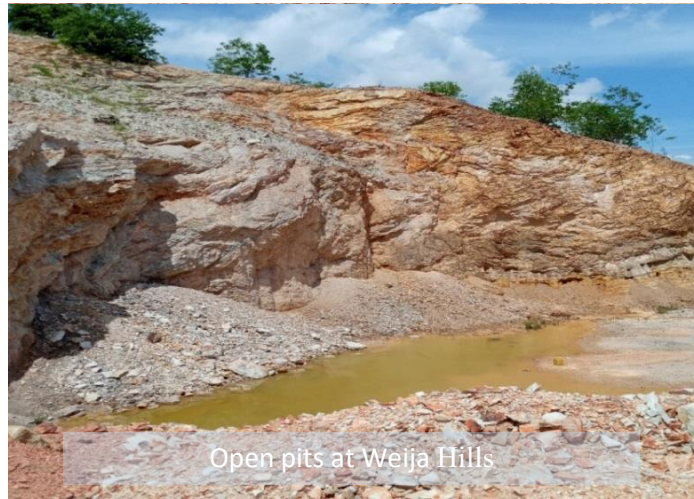
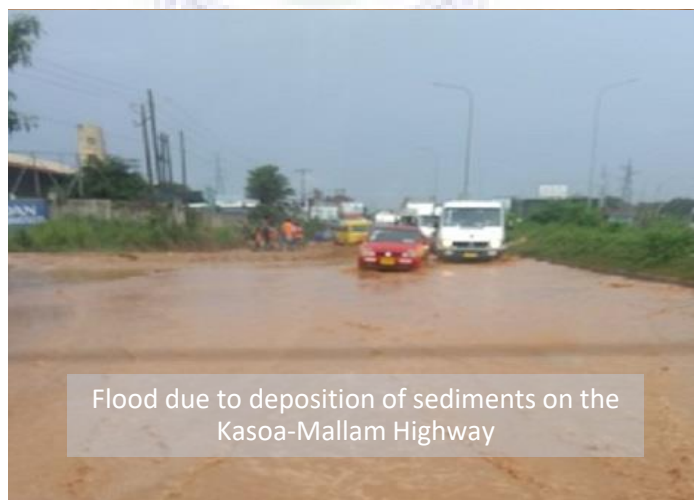
Figure 17: Examples of environmental effects on the Weija Hills and environs

The section reveals the various environmental changes at the Weija Hills due to quarrying activities in the area. The study observed the combination of erosion, loss of vegetative cover, deteriorating roads and loss of agricultural lands, disaster potential, open pits and dust were the major environmental effects of quarrying on the study area. The clearing of vegetation for quarrying activities around the Weija Hills had made the local environment bare causing various forms of water erosion. Anytime it rained heavily, the Kasoa to Mallam side of the highway (Site A) of the study area was always blocked by the eroded materials which flooded the road making vehicular movement virtually impossible unless the Authority (the Municipal assembly or Ghana Highways) came to clear the road of the sediments. Also, a portion of the recently constructed Tuba road has deteriorated because sediments from quarried Site B fills the drains and blocks it, as a result, rain water floods the road which has destroyed it within a short time. Again, the eroded parts of the hills had developed gullies and this could also be said of all the untarred roads which developed very rough rocky surfaces after downpours.

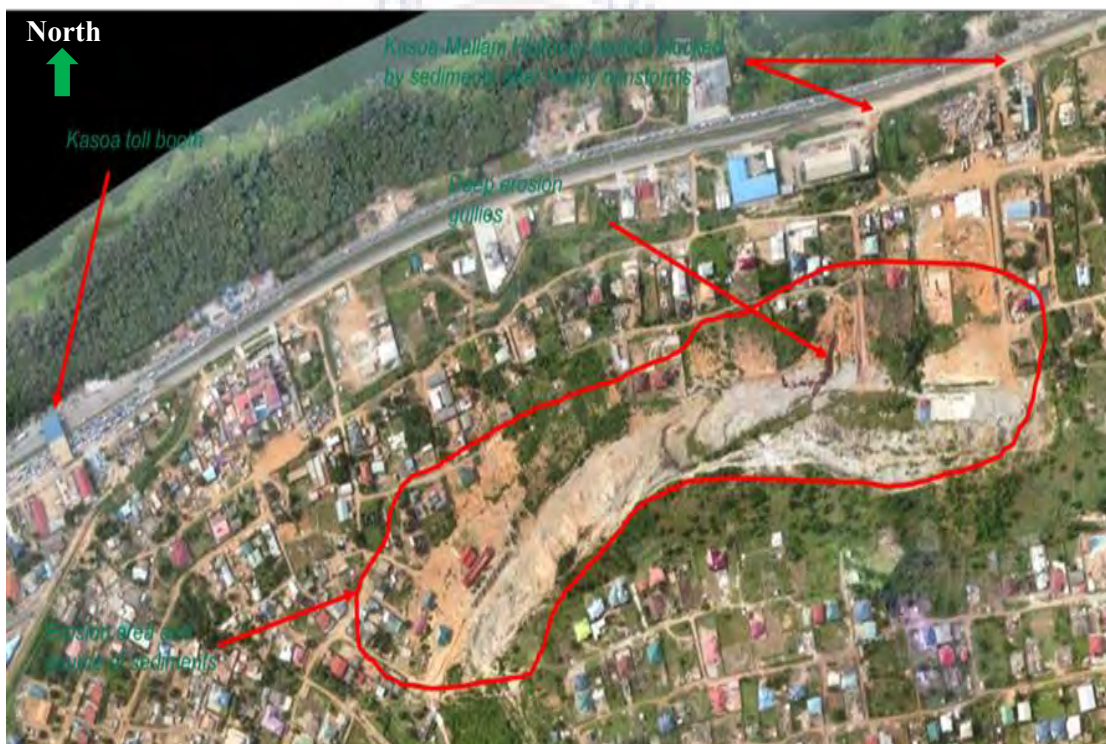
Figure 18: Site A of the Weija Hills Used for slope stability analysis. (The image is not drawn to scale.)

Aerial view of Akoasa Mountain problem area taken from drone.

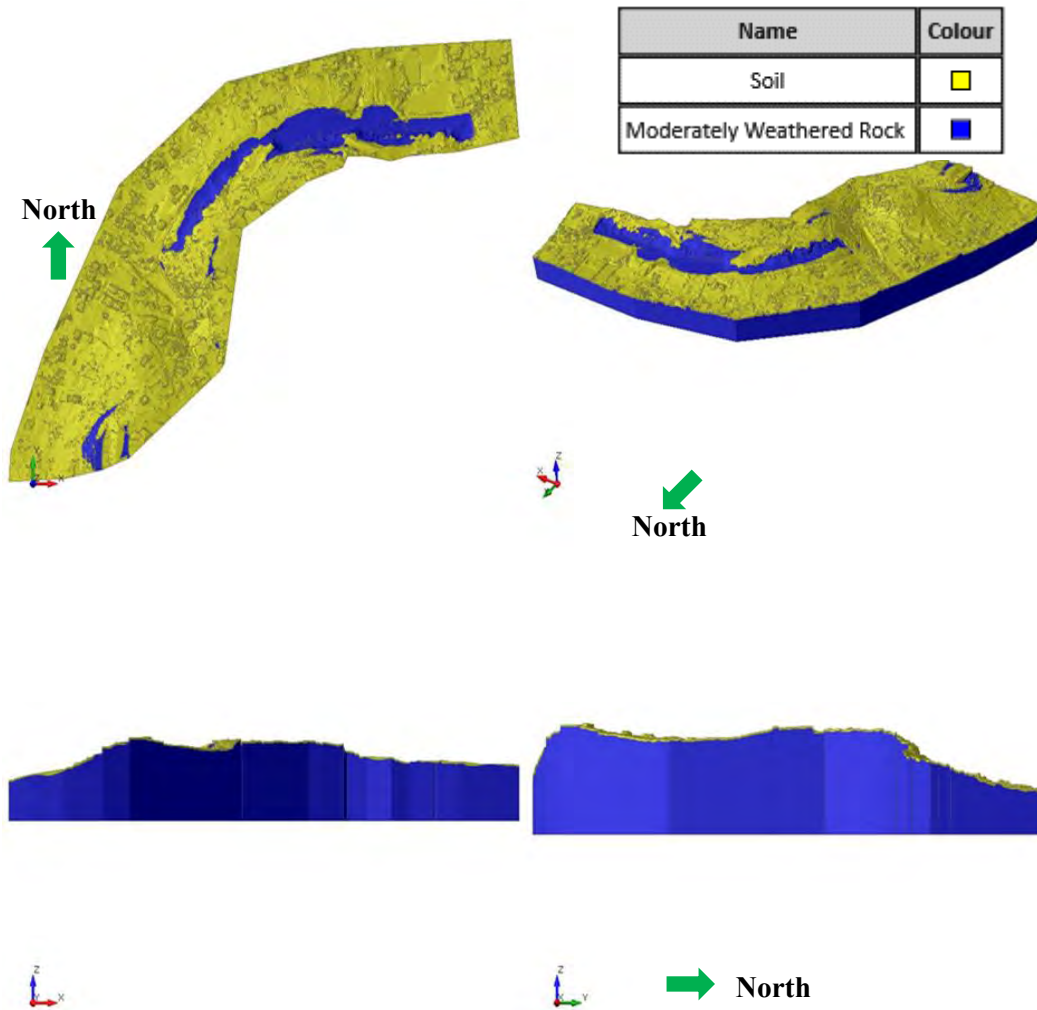
Figure 19: Images showing the plan, perspective and side views of the 3D slope model of quarry site A. In each of the views, North is parallel to the y-axis.

The slopes of Weija Hills were assumed to be pressurised by a water table approximately 3m below ground surface. This is a conservative assumption developed based on the field observations of the site, and the commonly accepted understanding of prevailing groundwater typical of such settings.
