INVESTIGATION INTO THE CAUSES OF CRACKS IN BUILDINGS IN THE
BOLGATANGA MUNICIPALITY
A CASE STUDY OF SABON ZONGO AND DAGMEW AREA
OF THE UPPER EAST REGION OF GHANA

2016

A DISSERTATION IN THE DEPARTMENT OF CONSTRUCTION AND WOOD
TECHNOLOGY EDUCATION, FACULTY OF TECHNICAL EDUCATION, SUBMITTED
TO THE SCHOOL OF GRADUATE STUDIES, UNIVERSITY OF EDUCATION,
WINNEBA IN PARTIAL FULFILLMENT OF THE REQUIREMENTS FOR THE AWARD
OF MASTER OF TECNOLOGY EDUCATION (CONSTRUCTION) DEGREE

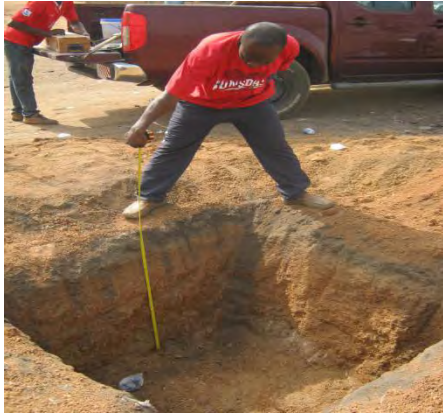
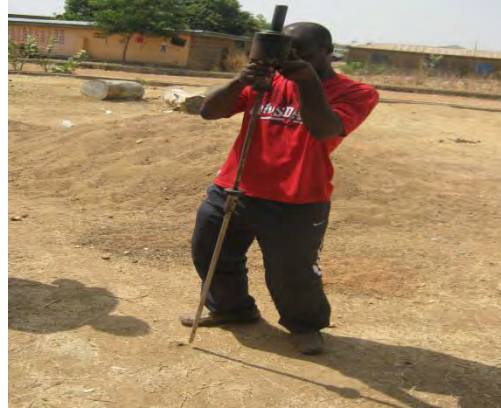
Weight of hammer	-	10kg
Height of fall of hammer	-	500mm
Cone diameter	-	24mm
Cone surface area	-	6.4cm ²
Cone apex angle	-	90 ⁰

- i. The first step of the test was to put the cone tip on the testing surface

- ii. The lower shaft containing the cone was moved independently from the 5 reading rod sitting on the testing surface throughout the test
- iii. The initial reading is not usually equal to 0 due to the disturbed loose state of the ground surface and the self-weight of the testing equipment. The value of the initial reading was counted as initial penetration corresponding to blow 0

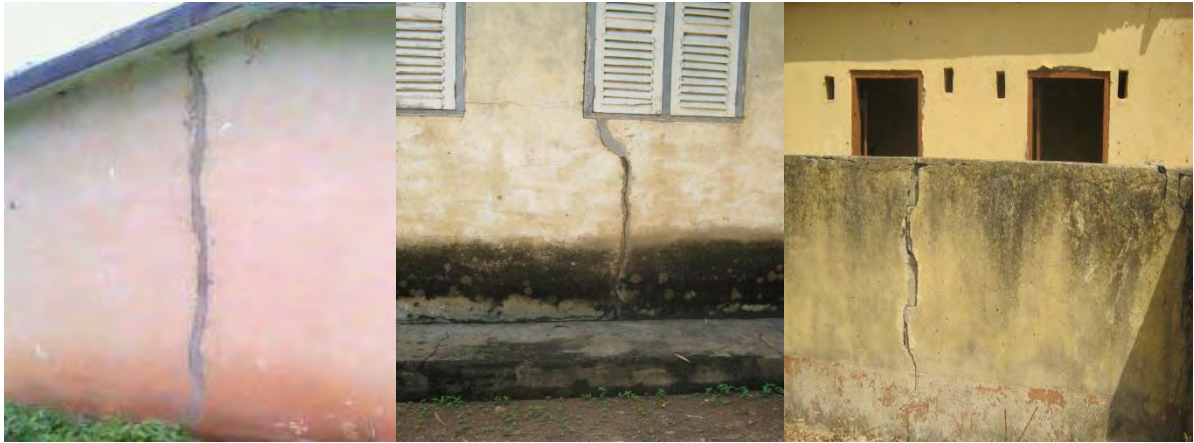
The major type of cracks in the buildings observed from the two project sites was vertical cracks. Photocredit one to three shows the nature of the vertical cracks in the buildings studied.

Figure 4.1

Figure 4.2

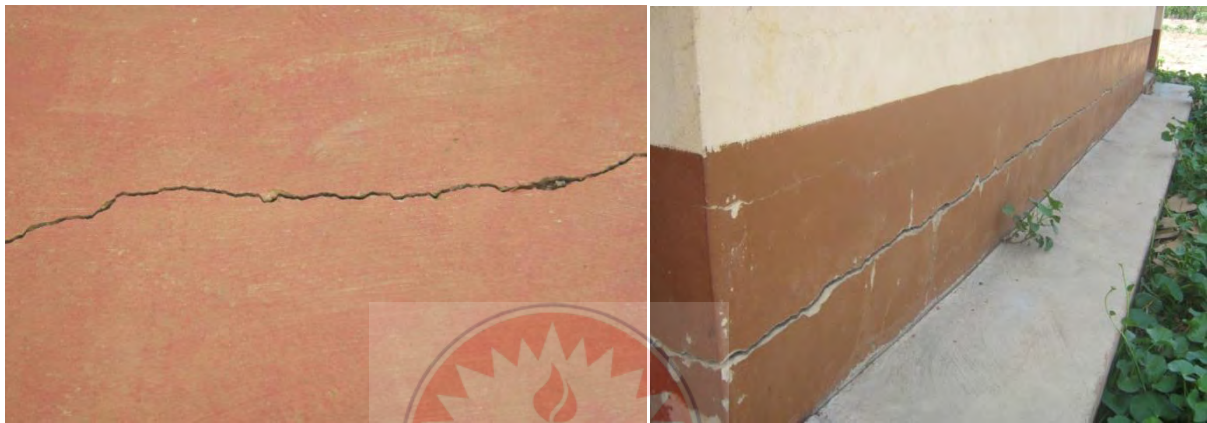
Although not significant, the horizontal types of cracks were also identified among a number of buildings in both project sites as illustrated in Figure 4.4 and 4.5.

Figure 4.4: Horizontal cracks

Figure 4.5: Horizontal cracks

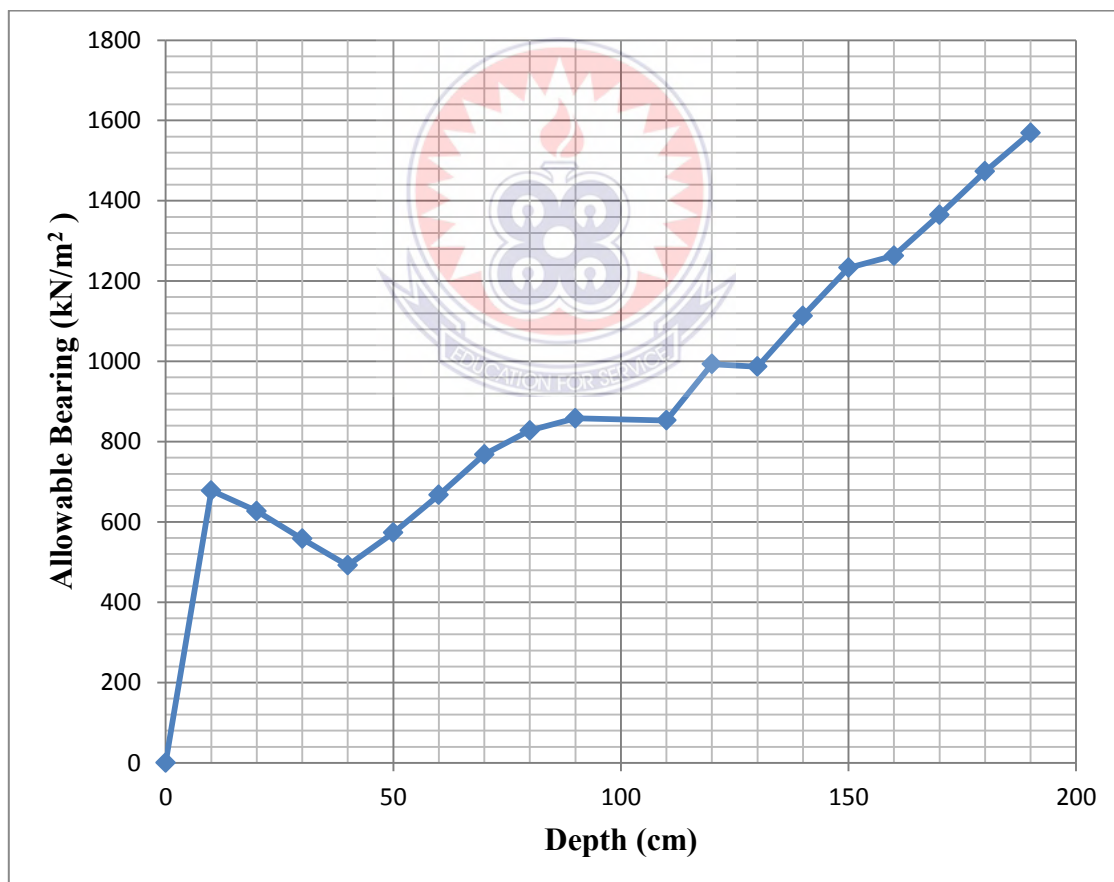
Figure 4.6: Allowable bearing at Sabon Zongo project site

Table 4.6 shows that the largest allowable bearing was noted for the largest depth (Depth 180, allowable bearing= 1569.00) with a standard deviation of 106 and 83.74 respectively. On the other hand, the least allowable bearing was noted for depth of 40 cm (allowable bearing = 492.00). Generally, penetration depth of 70 cm and beyond consistently had their corresponding allowable bearing capacities being increased. An assessment of the standard deviation also shows that the variability in allowable bearing seemed to reduce after a depth of 140 cm. Figure 4.5 further shows the graphical view of the various allowable bearing across the various depths at the Sabon Zongo project site

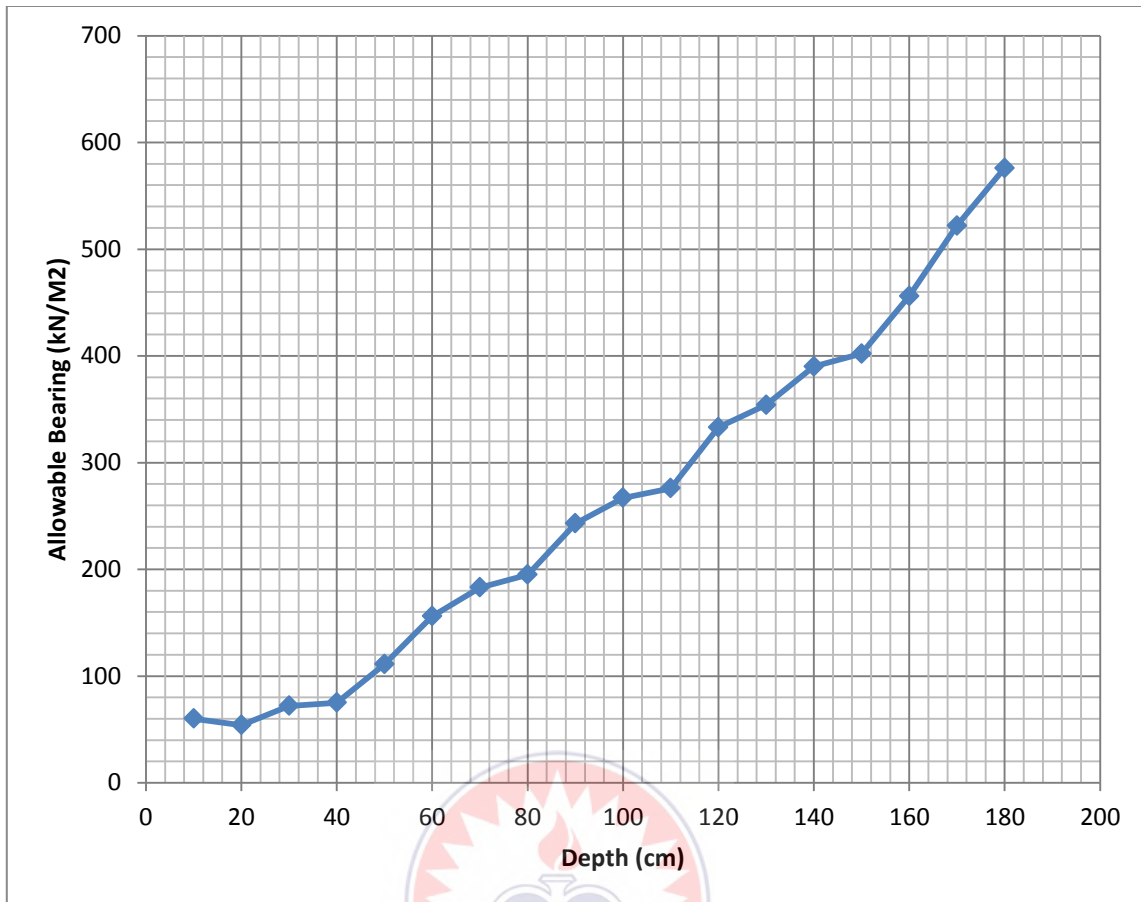
Figure 4.7: Allowable bearing capacity across various depths at Dagmew and Sabon Zongo project sites

The allowable bearing capacity for Dagmew project site is smaller at the smallest depth while the opposite is seen for the largest depths. For example, the allowable bearing capacity at a depth of 180 cm (Allowable bearing capacity = 57260) was 512 larger than the allowable bearing capacity at a depth of 10 cm (Allowable bearing capacity = 60). Figure 4.6 gives a clear picture of the result in Table 4.6

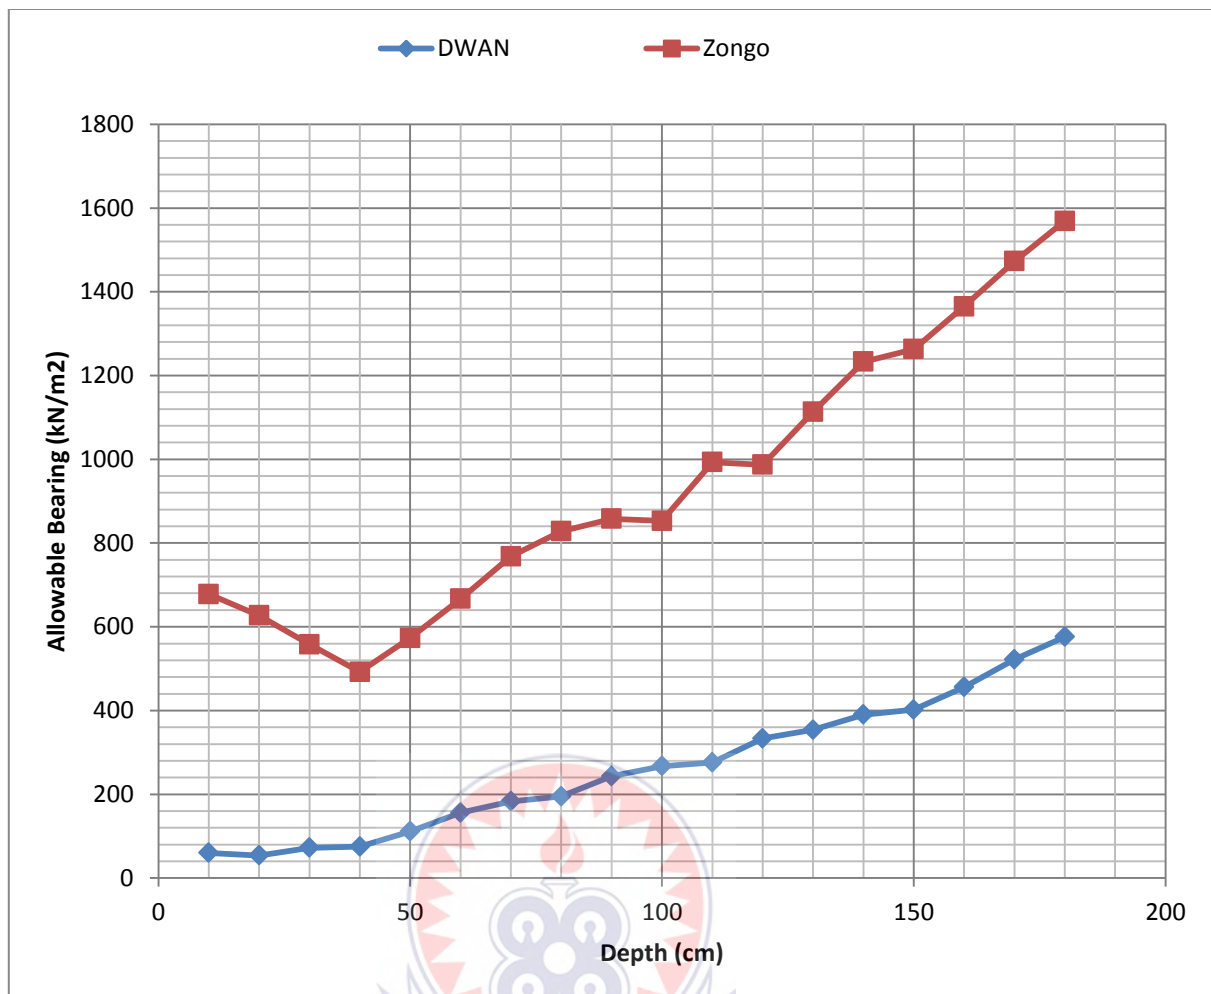
Figure 4.7: Allowable bearing across Sabon Zongo and Dagmew

Generally, it is noted that the bearing allowance for all the depths in Sabon Zongo far outweighed that of the bearing allowance for Dagmew. For example, at a 10 cm depth, an allowable bearing capacity of 678 was recorded for Sabon Zongo while at the same depth, only 60 allowable capacity was noted for Dagmew. In other words, at a 10 cm depth, the bearing capacity at Sabon Zongo was 616 kN/cm more than the bearing capacity at Dagmew. In a similar vein, at 180 cm, an allowable bearing capacity of 1569 kN/cm was recorded at Sabon Zongo as against allowable bearing of 572 at the same 180 depth for Dagmew. Figure 4.7 illustrates the graphical view of the allowable bearing capacity across the two sites of study.

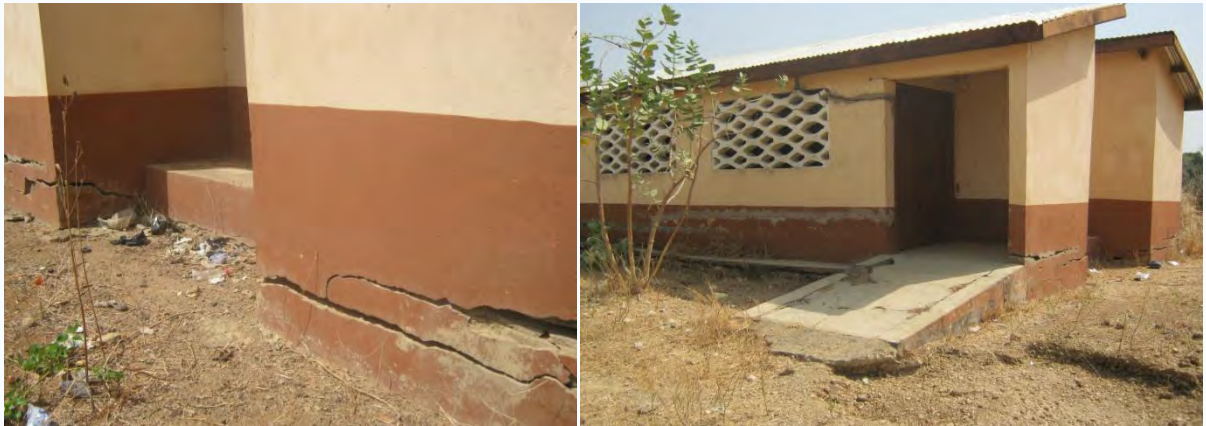
A volt chamber toilet facility which suffered all manner of cracks at Anglican JHS premises due to expansible nature of the sub-soil of the Dagmew Residential Area.

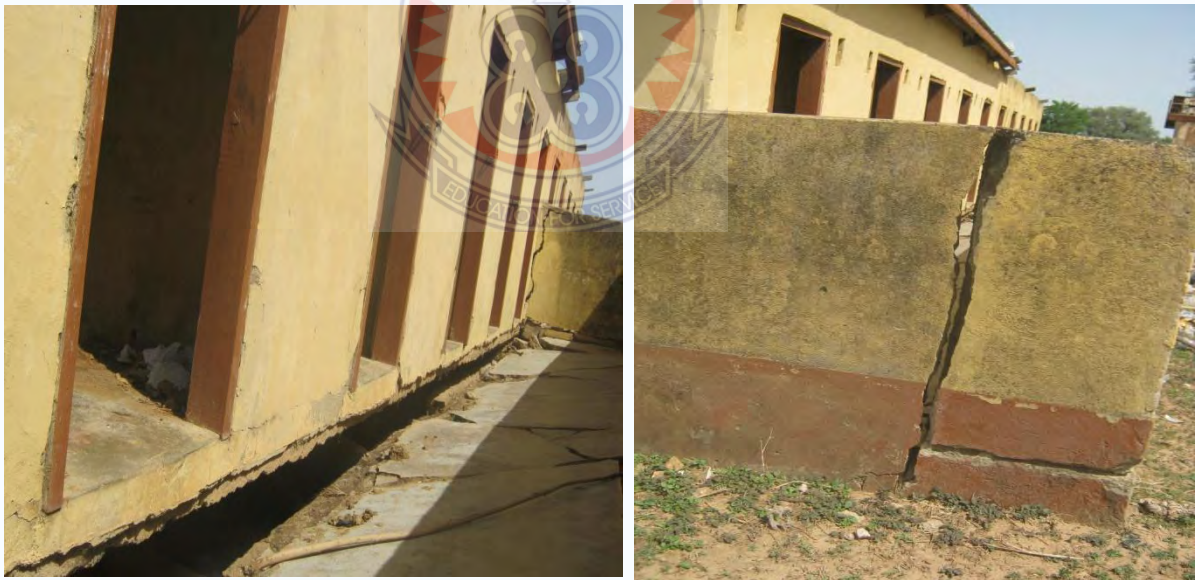
A 10-seater KVIP toilet facility which developed terrible cracks suspected to occur as a result of the clayey nature of the sub-soil at the same Anglican JHS premises, Dagmew.

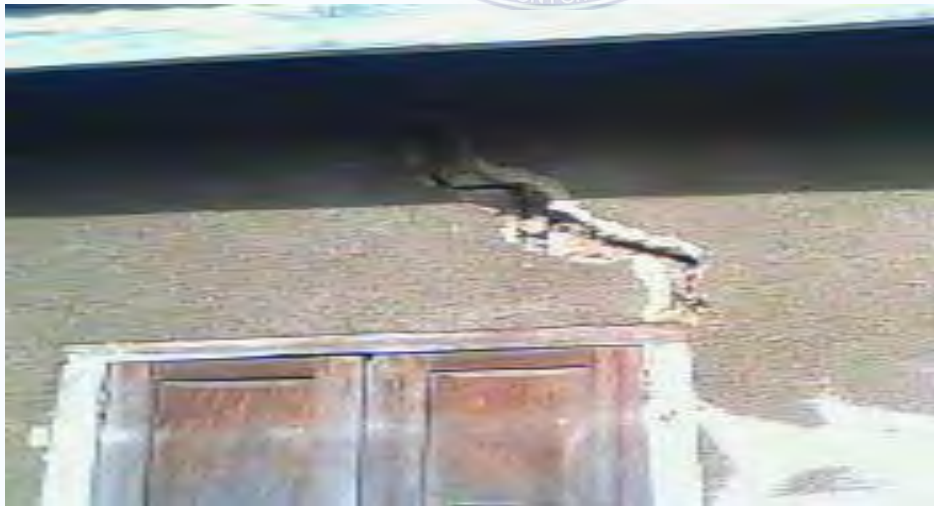
A building that cracked through a lintel which is an indication of operational error emerging from the lintel construction in the Sabon Zongo Residential Area.

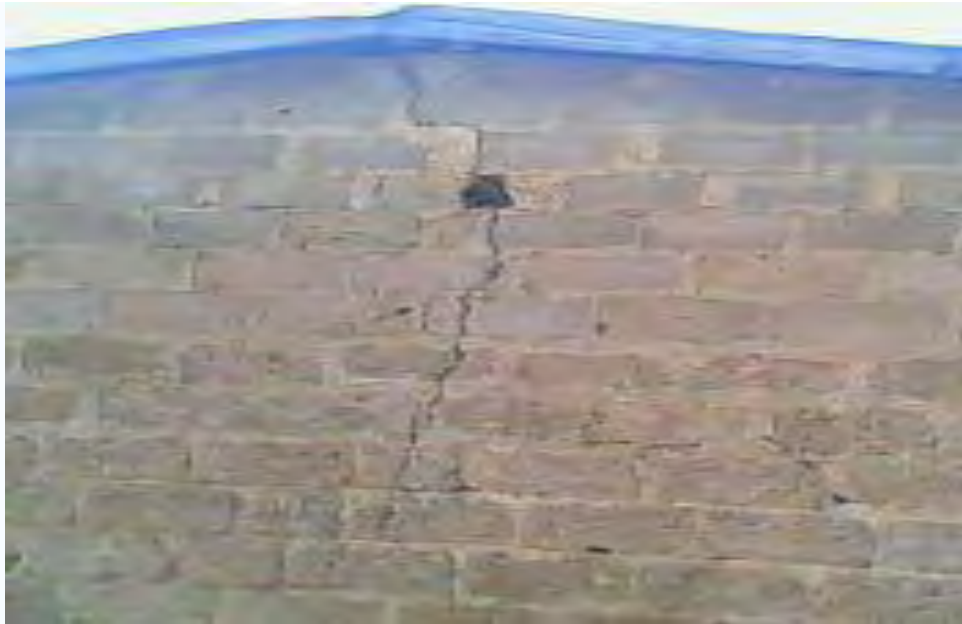
Another building that developed crack from floor level to gable, clearly showing that there is no lintel in the wall at Sabon Zongo Residential Area.

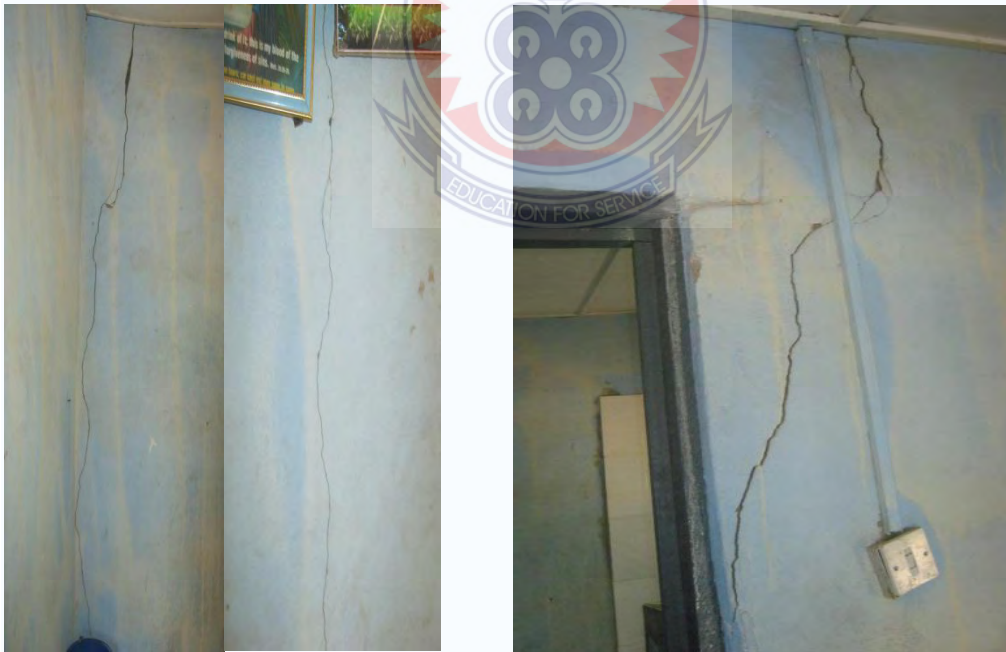
Another building that developed several cracks at various locations at Sabon Zongo. Photograph taken inside the building as the landlord expressed his frustrations about the development and took the researcher in for a technical advice.

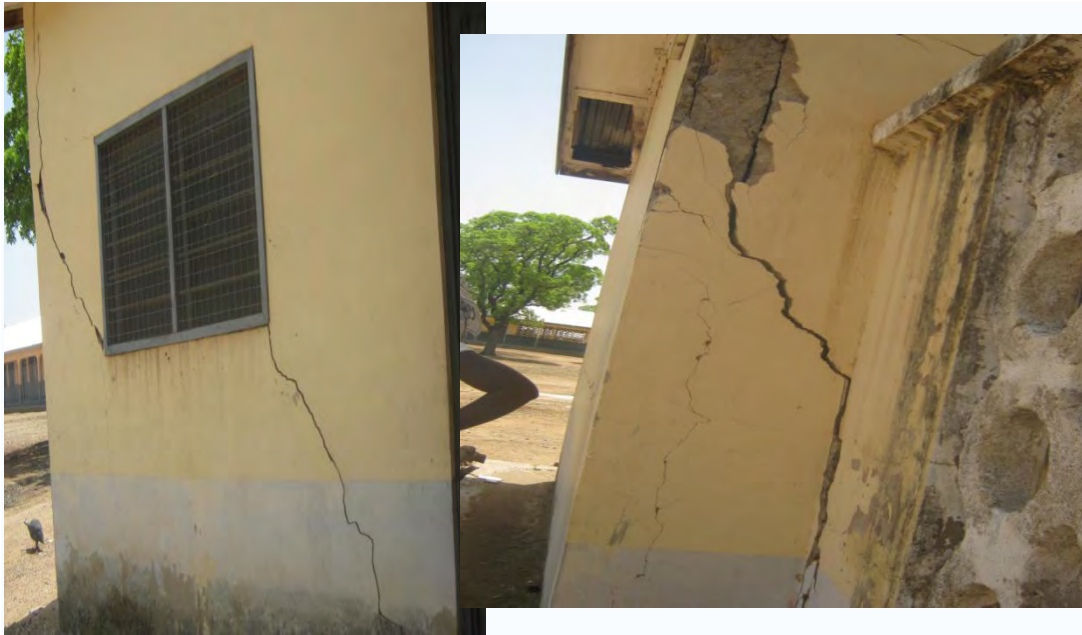
A 3-Unit apartment teachers' quarters at Ananteem in the Bolgatanga Municipality that has been abandoned due to several terrible structural cracks.

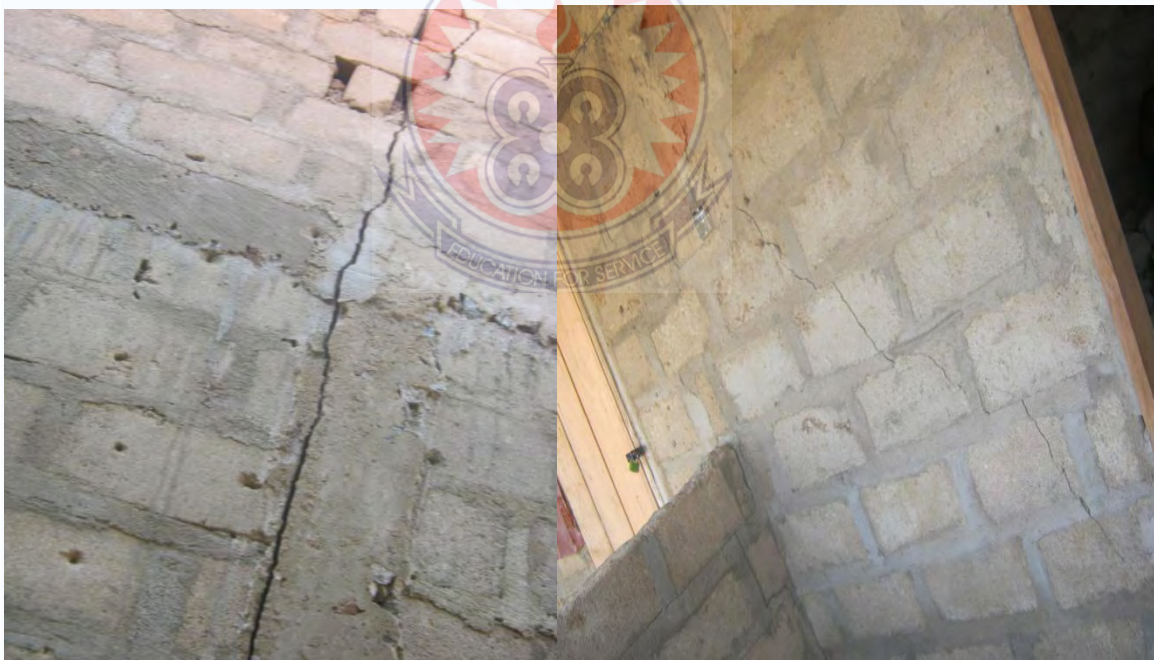
A building under construction that suffered serious structural cracks due to operational and/or constructional error at Sumbrungu in the Bolgatanga Municipality.

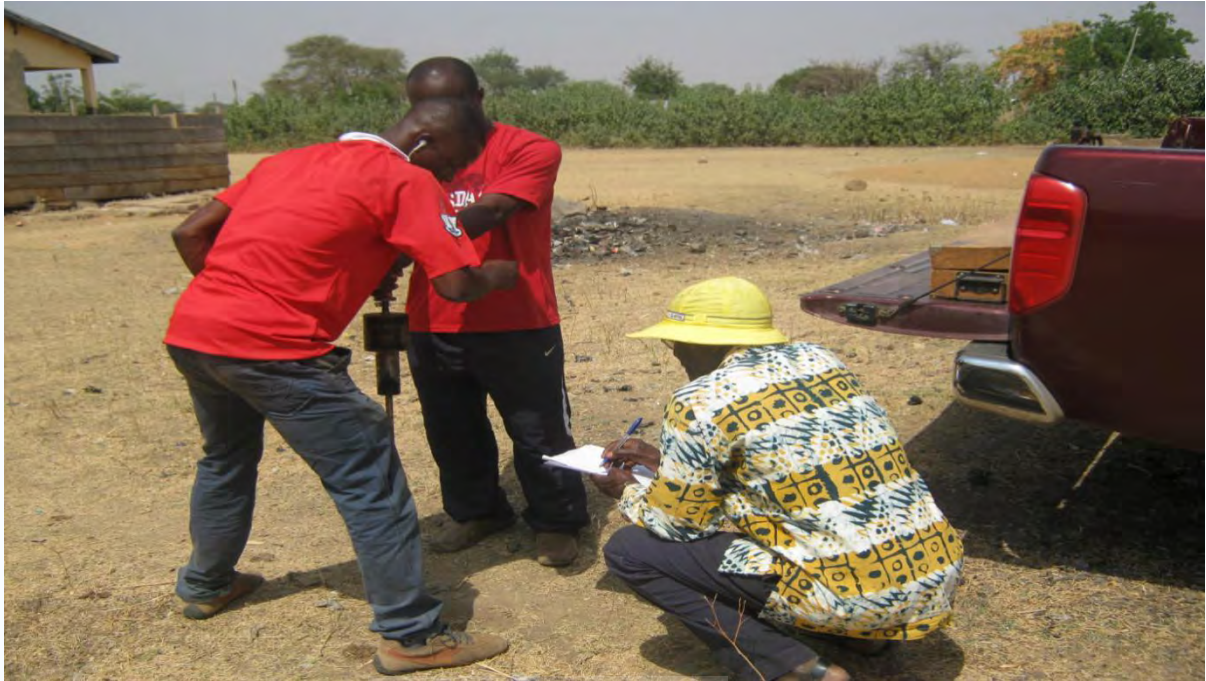
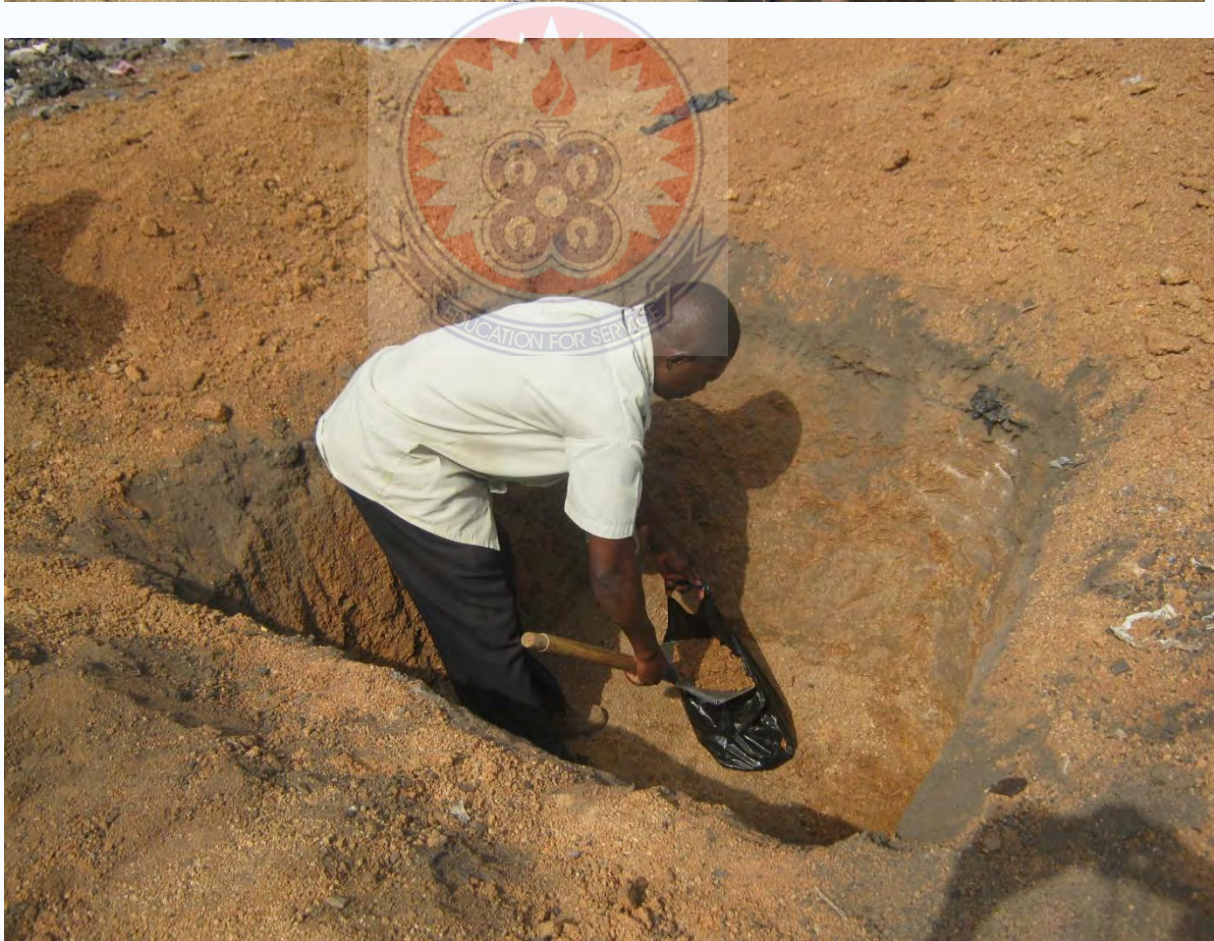
Trial pits and Dynamic Cone Penetrometer Tests at the project sites.

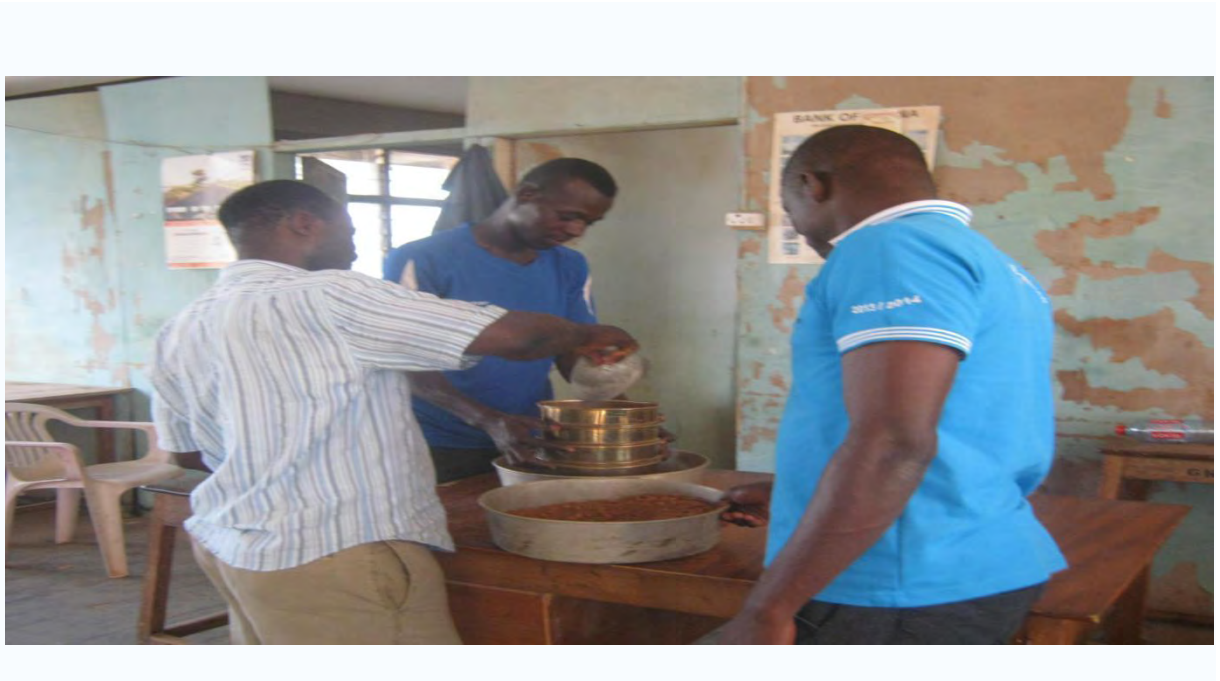
Sieve, plasticity and sedimentation tests/analysis.

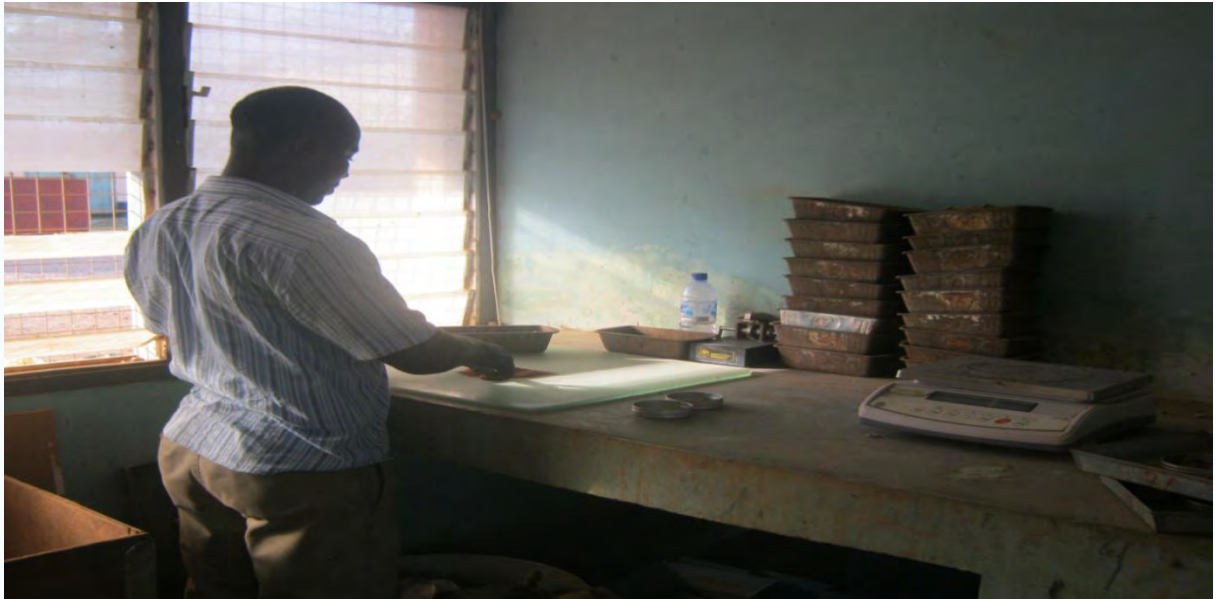
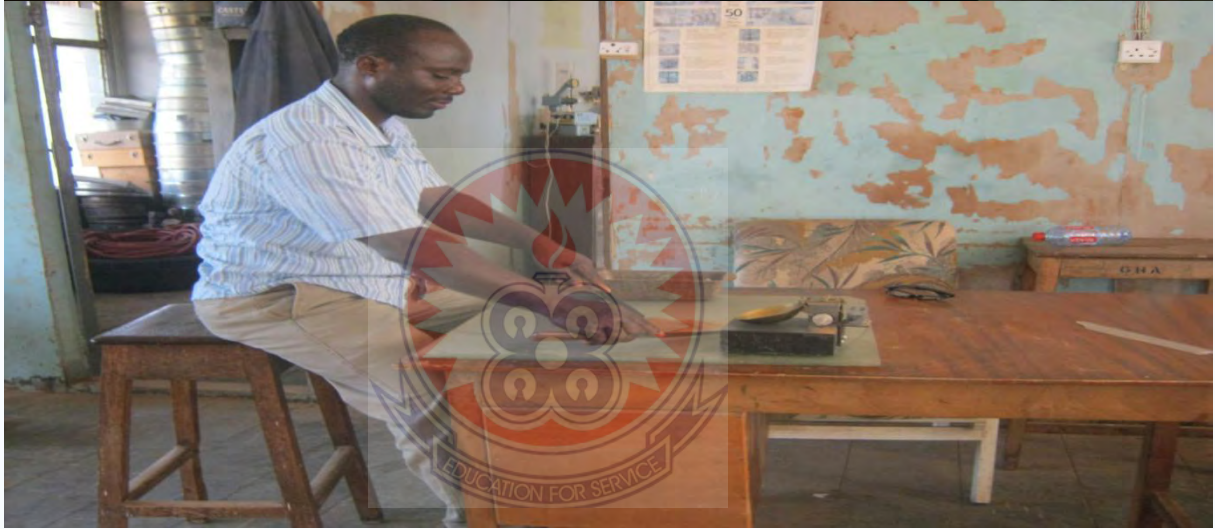
Sieve, plasticity and sedimentation tests/analysis.
