**ADOPTION OF APPROPRIATE MEASURES TO MINIMIZE THE EFFECTS
OF FLOODS ON HOUSING IN THE THREE NORTHERN REGIONS OF
GHANA: THE PERSPECTIVE OF CONSULTANTS**

AUGUST, 2015

**A Dissertation Submitted in the Department of CONSTRUCTION AND WOOD
TECHNOLOGY EDUCATION, Faculty of TECHNICAL EDUCATION, School
of Graduate Studies, University of Education, Winneba, in partial fulfillment of
the requirements for the award of Master of Philosophy (Construction
Technology) degree.**

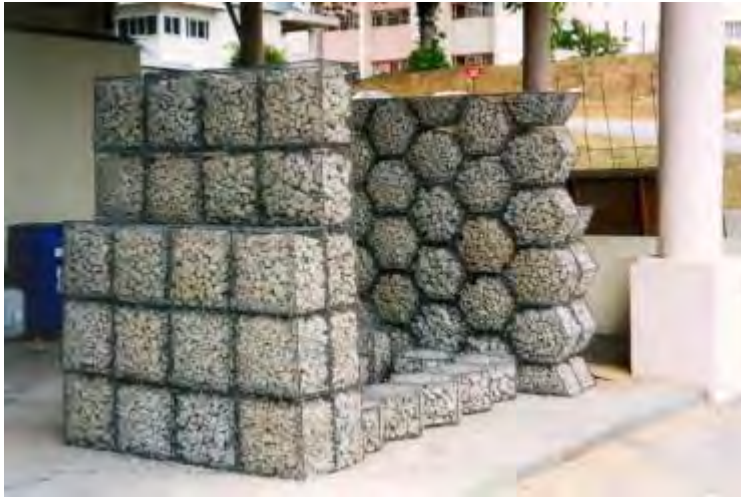
Figure 2.2: Twin Wall Construction

Two sets of retaining walls composed of each gabion type were constructed for evaluating the mechanical responses of the conventional gabion wall versus the hexagonal wall to external load. The walls were of 1.80 m height and 1.75 m width and spaced 1.80 m from each other. The height-to-base ratio of each wall was purposely designed to be excessive in order to permit large deflections, although overturning moments were not tolerated in the interest of safety. Each wall was built with a stepped front-face and smooth back-face that reduces the wall thickness by 50% at three-fifths of the wall height from its base to the top. The introduction of burnt clay brick wall according to Kombe (2000) is crucial in terms of cost effectiveness instead of twin retaining wall when excessive flood water is to be resisted.
